00248.00.0002.05.0000

September 28, 2000

Subject: **Sullivan Creek Project**  
**Underwater Inspection of Mill Pond Dam Plunge Pool and Toe**

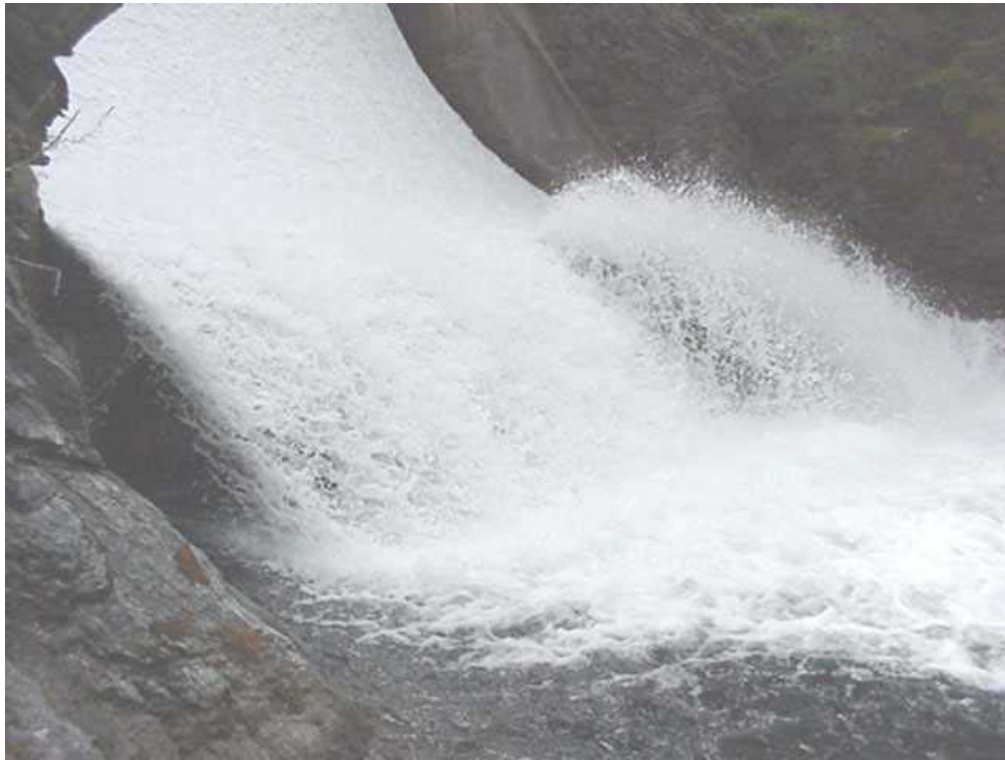
Spill at toe of Mill Pond Dam

At the toe on the left side, spill struck a large rock outcrop that extends above the sill of the toe. On the right side, the training wall diverted spill away from the rock bank.

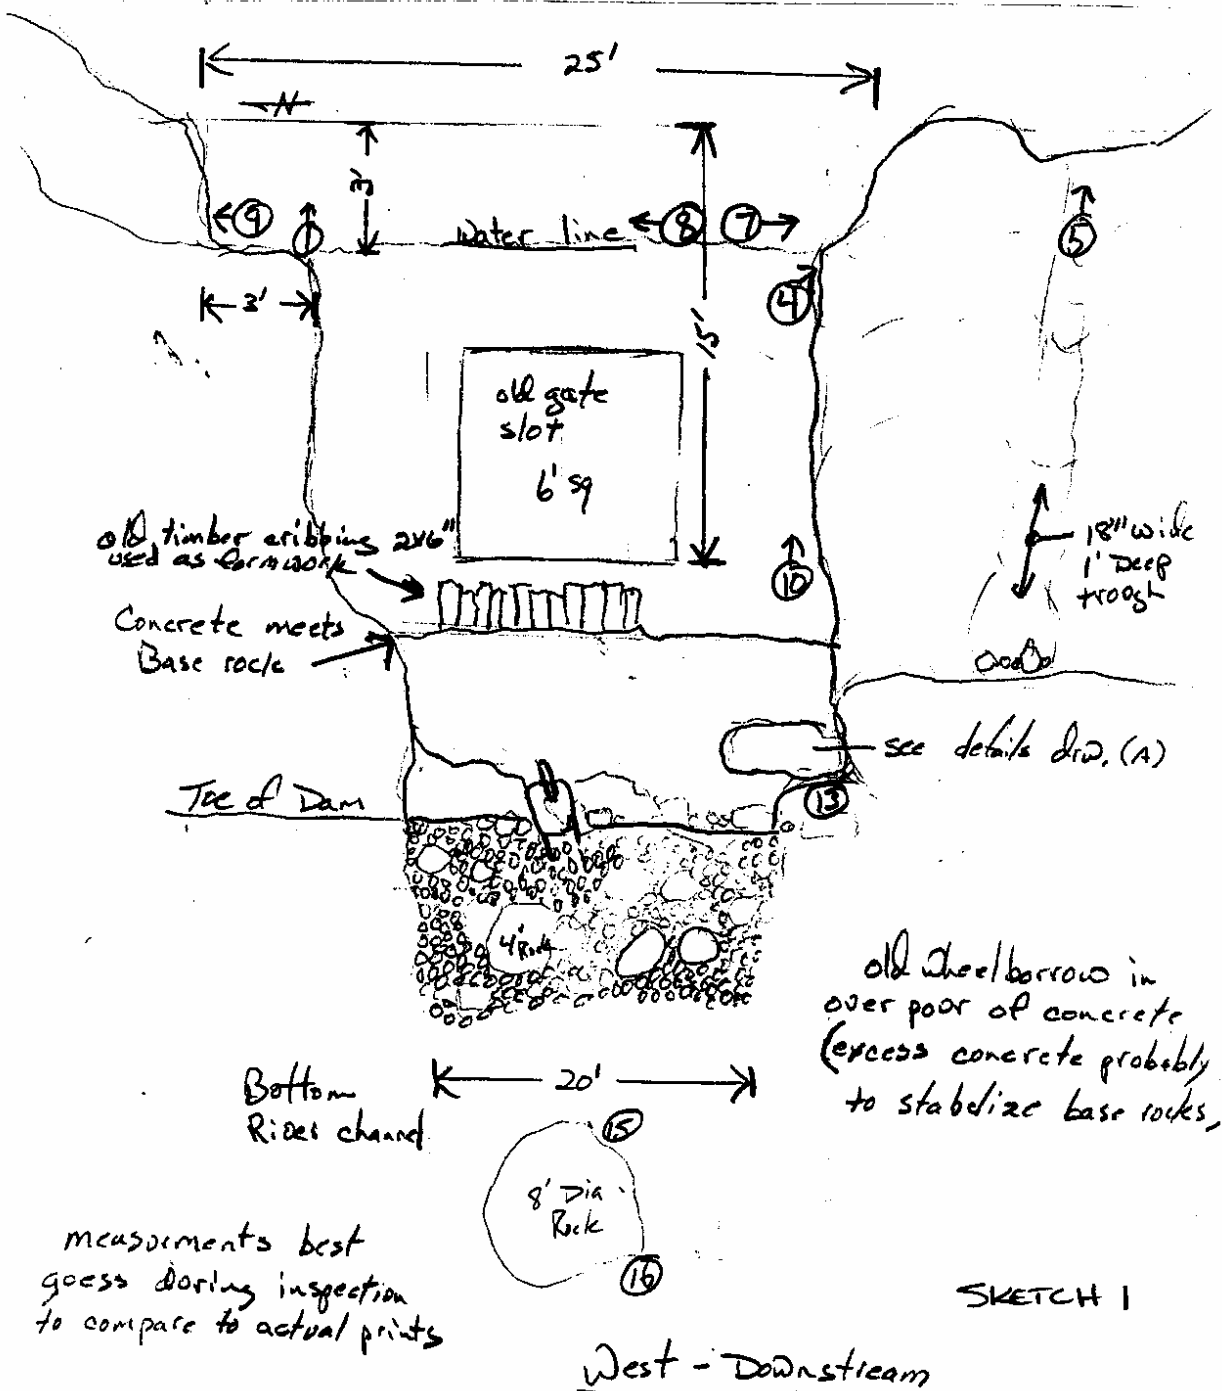
MILL POND DAM SPILLWAY 8 September 2000

The only evidence of erosion the diver saw was a 3ft high by 4 ft wide by 2 ft deep hole in the rock face on the left side, well below the water surface. The location and details of the hole are shown on Sketch 1 and 2. The hole may have been left by a dislodged rock but the diver noted the missing rock was not evident. The diver reported there was no evidence that the hole developed recently or is currently being scoured. The condition of the rock face does not

The diver observed a trough in the massive rock on the left side of the toe (see Sketch 1). The diver reported that the trough appeared to have been excavated, and was not natural looking. It is possible that this trough was used for diverting water during construction. The diver also observed and noted concrete on the bottom of the plunge pool on the right side. A wheelbarrow was found embedded in the concrete.

endanger the dam and therefore no corrective measures or repairs are deemed necessary to prevent further erosion.

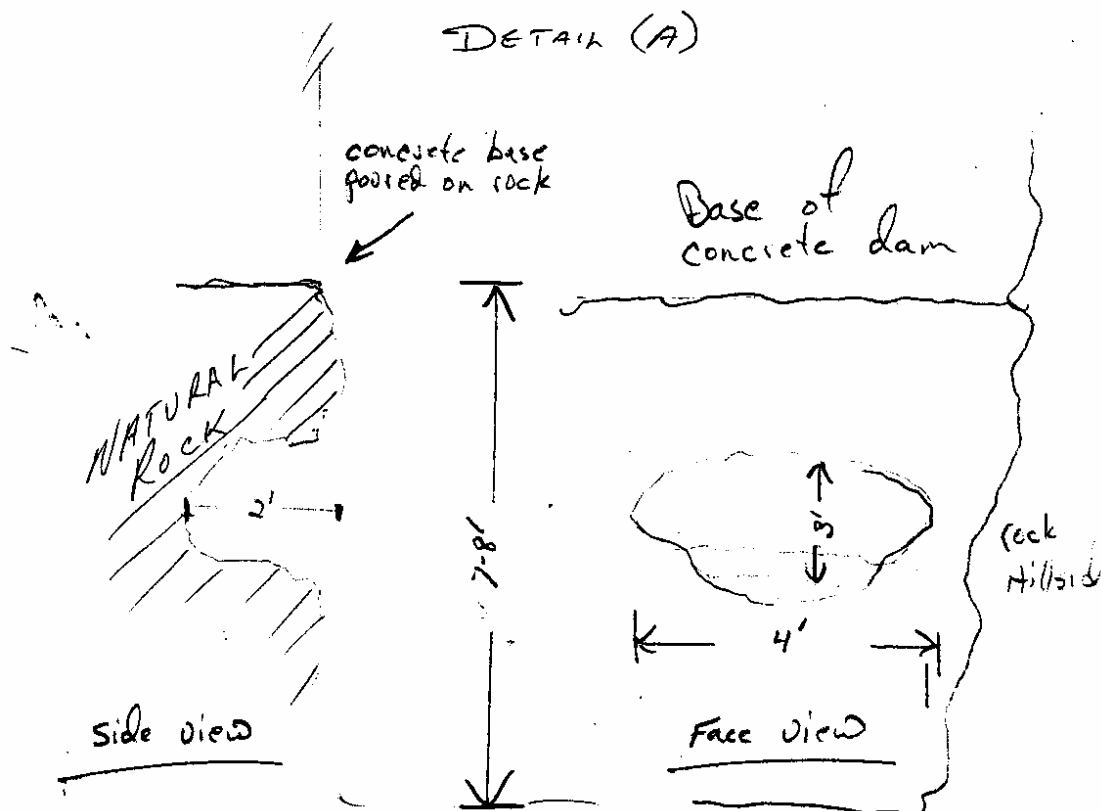
SKETCH 2

Details of undercut area

appears to have broken out  
No new broken or missing rock evident

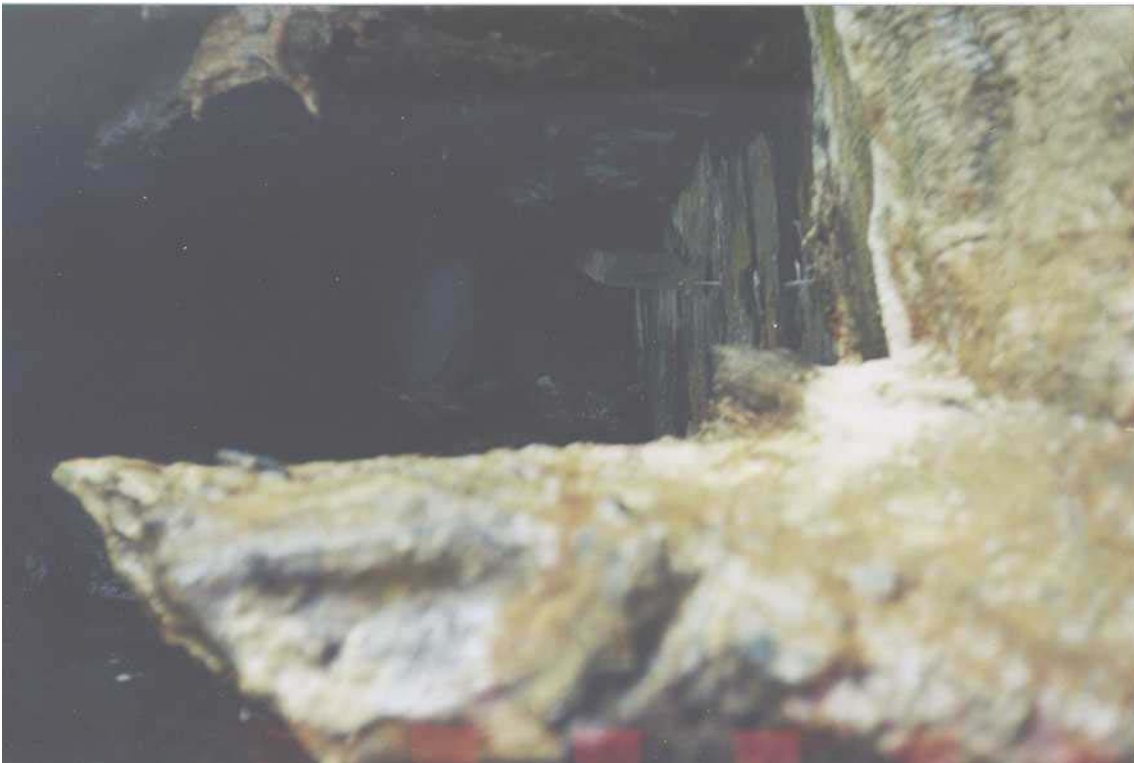
Photo 9

Timbers used for cribbing and formwork during historic repairs are intact at the toe of the concrete. In-place timber forms were also seen in a hole in the rock on the right side above the water (see Photo 9). These timber forms apparently were used to seal a void for concrete placement on the upstream side of the rock. Photo 8 shows an apparent horizontal joint in the concrete right above the water line. The location of this joint appears to closely coincide with the base of the dam shown on the original cross section drawing of Mill Pond Dam (Section B-B, Figure 7 of the 2000 Safety Review).

The current stability evaluation considers the base elevation of the dam to be at or very close to the horizontal joint just above the water line shown in Photo 9. The massive block of concrete below that level appears to be keyed well into the rock. The passive resistance available to the dam due to embedment into the rock foundation is believed to be significant based on typical shear strength properties of the rock (phyllite). This passive resistance contributes to the sliding resistance and significantly increases the shear-friction safety factor for Mill Pond Dam.

- Photo's
- #1 Looking Upstream over rock ledge.
  - #4 Looking over rock outcropping
  - #5 Trough area that extends from the top of the outcropping to the base of the rock
  - #7 Looking South at waterline to outcroppings that extend above spillway
  - #8 Looking North from same spot as #7
  - #9 View of North corner of the CRIB area in rocks
  - #10 Looking UP around rock to concrete intersection.
  - #13 View of base of dam at South side.
  - #15 Old gate frame bent around 8' dia. rock.
  - #16 Typical rock bottom of river channel. River drops about 3 feet between the dam and a 8' rock that is about 30' downstream of the dam. River bottom consist of rounded rock 3-10 inches in diameter.
